UNDERWATER BRIDGE INSPECTION REPORT

STRUCTURE NO. 07542

BLUE EARTH RIVER

DISTRICT 7 - BLUE EARTH COUNTY

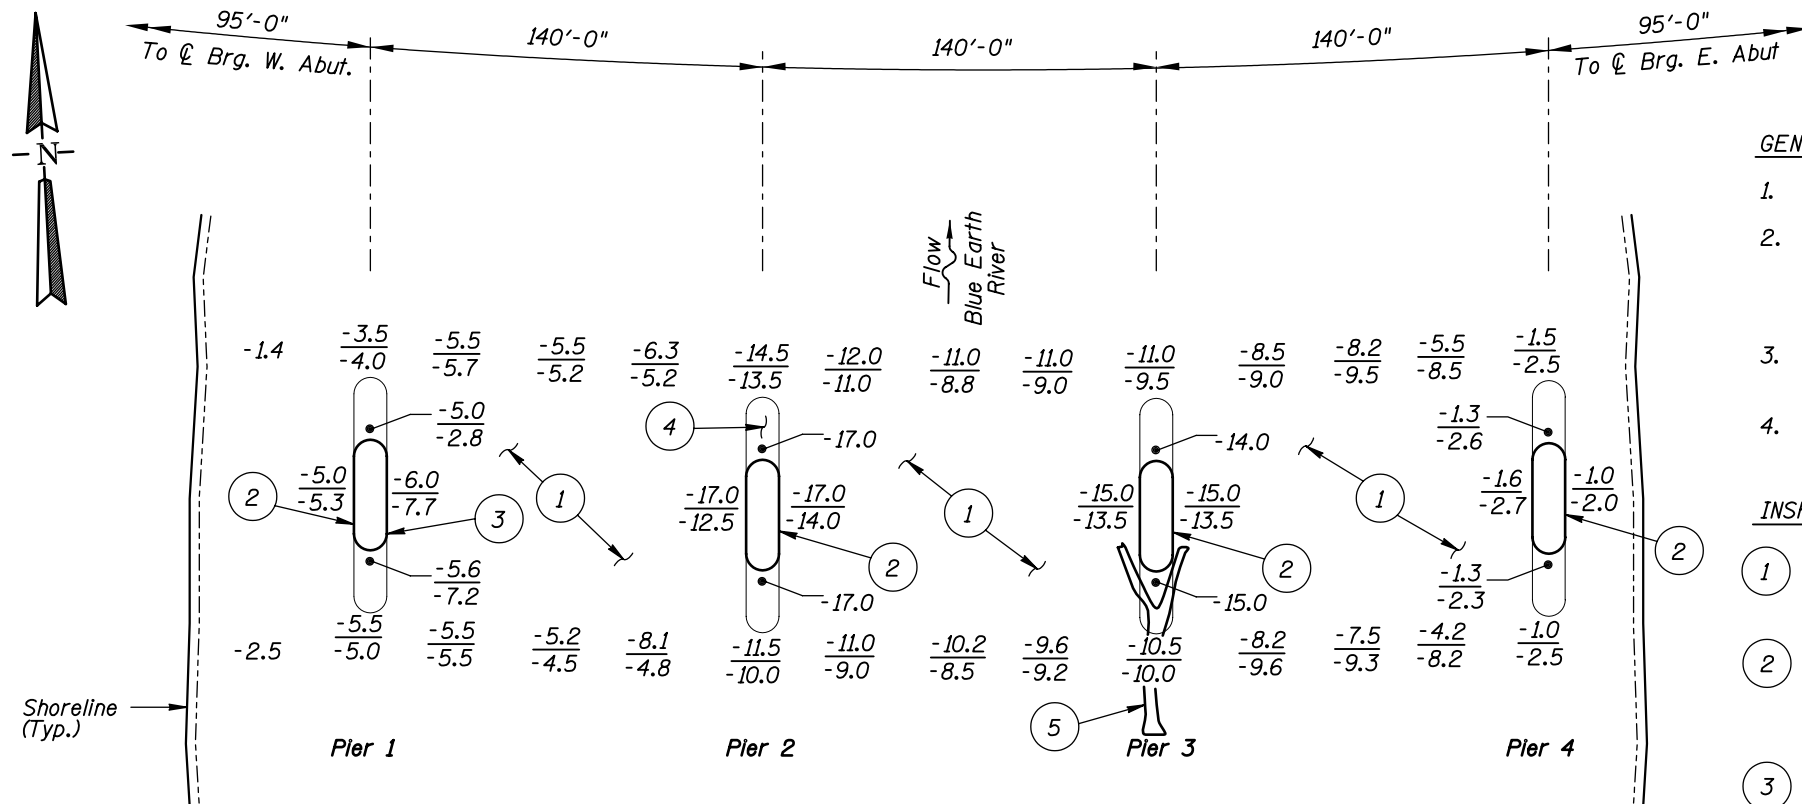
INSPECTION AND SOUNDING PLAN

- The channel bottom material consisted of soft silt with up to 2 feet of probe rod penetration.
- Light scaling with exposed aggregate was observed along center section of all of the piers with a maximum penetration of 1/4 inch.
- An area of section loss was observed 6 inches below the waterline on the southeast corner of Pier 1 and was 1 foot high by 6 inches wide with up to 1 inch of penetration.
- The remains of the sheet pile cofferdam used during original construction were observed along the downstream nose of the pier.
- A 2 foot diameter tree trunk was observed at the upstream nose of the pier and extended from the channel bottom to 5 feet above the channel bottom.

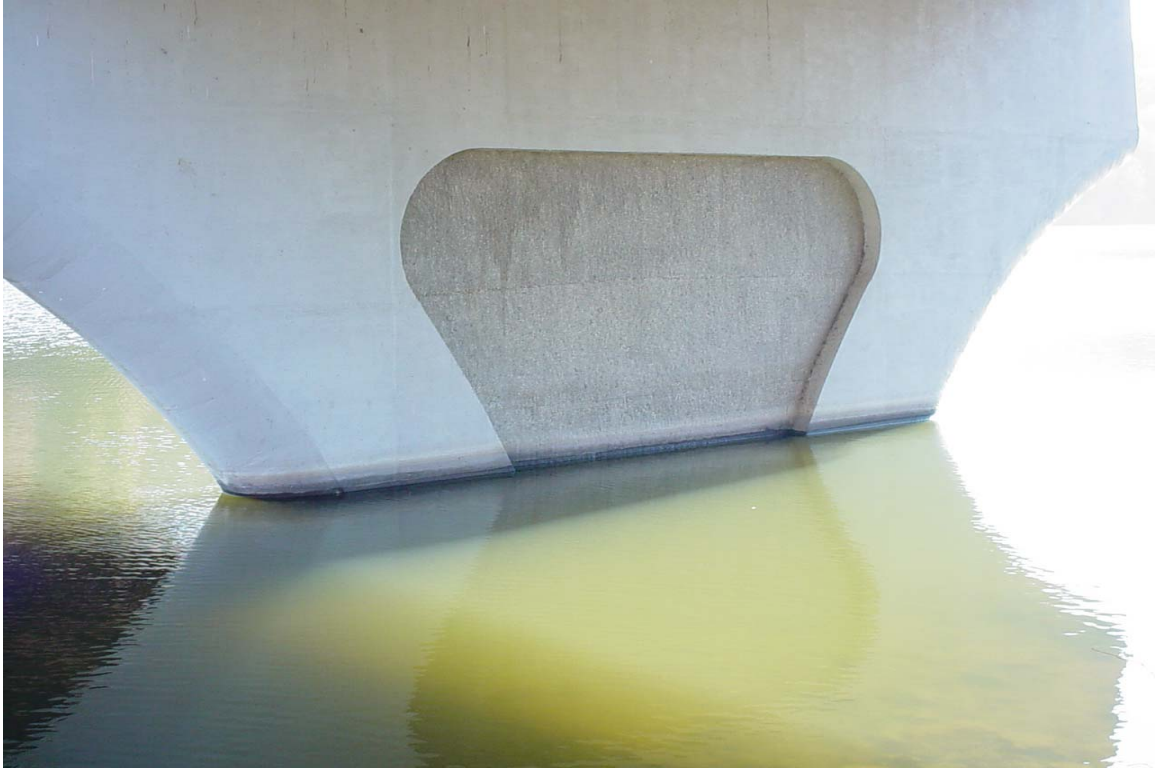
- (A) Light scaling with exposed aggregate was observed along center section of all of the piers with a maximum penetration of 1/4 inch.
- (B) An area of section loss was observed 6 inches below the waterline on the southeast corner of Pier 1 and was 1 foot high by 6 inches wide with up to 1 inch of penetration.
- (C) A 2 foot diameter tree trunk was observed at the upstream nose of Pier 3, extending from the channel bottom to 5 feet above the channel bottom.

Photograph 3. View of Pier 1, Looking Southeast.

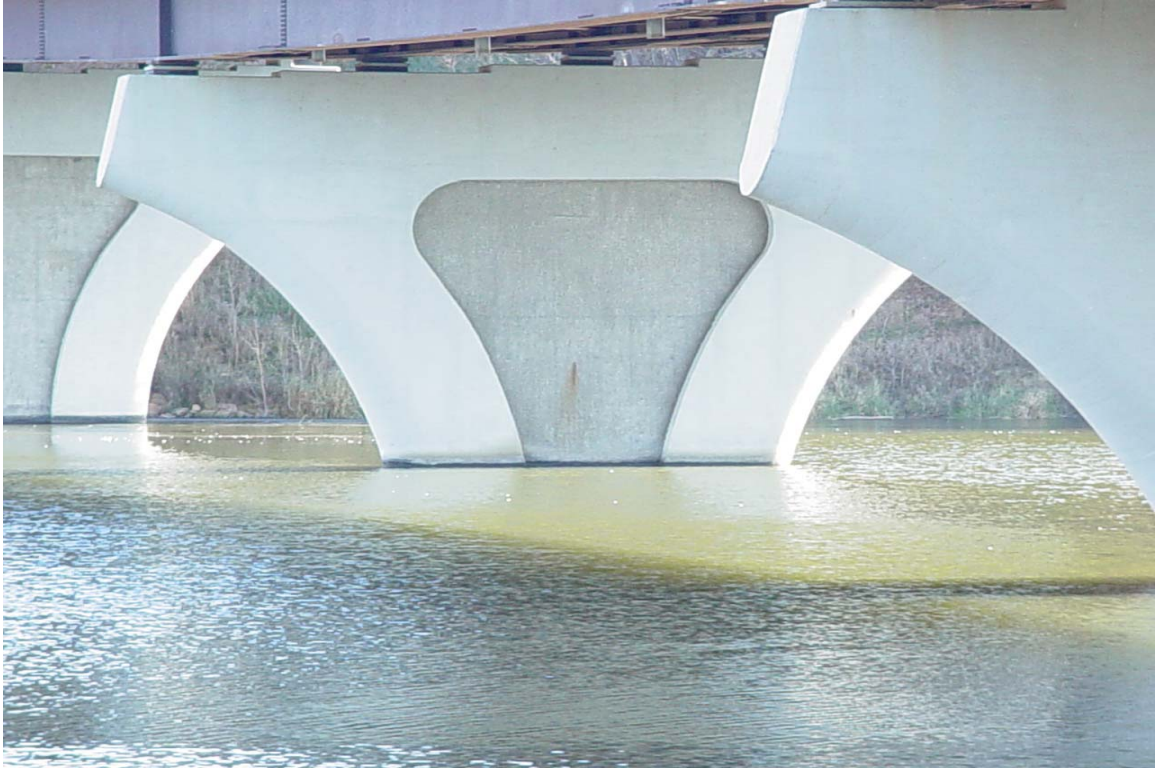
Photograph 5. View of Pier 3, Looking Southeast.
